# *Communique*

## *Airliner 1900 Series*

Communiqué #71  
June 25, 2004

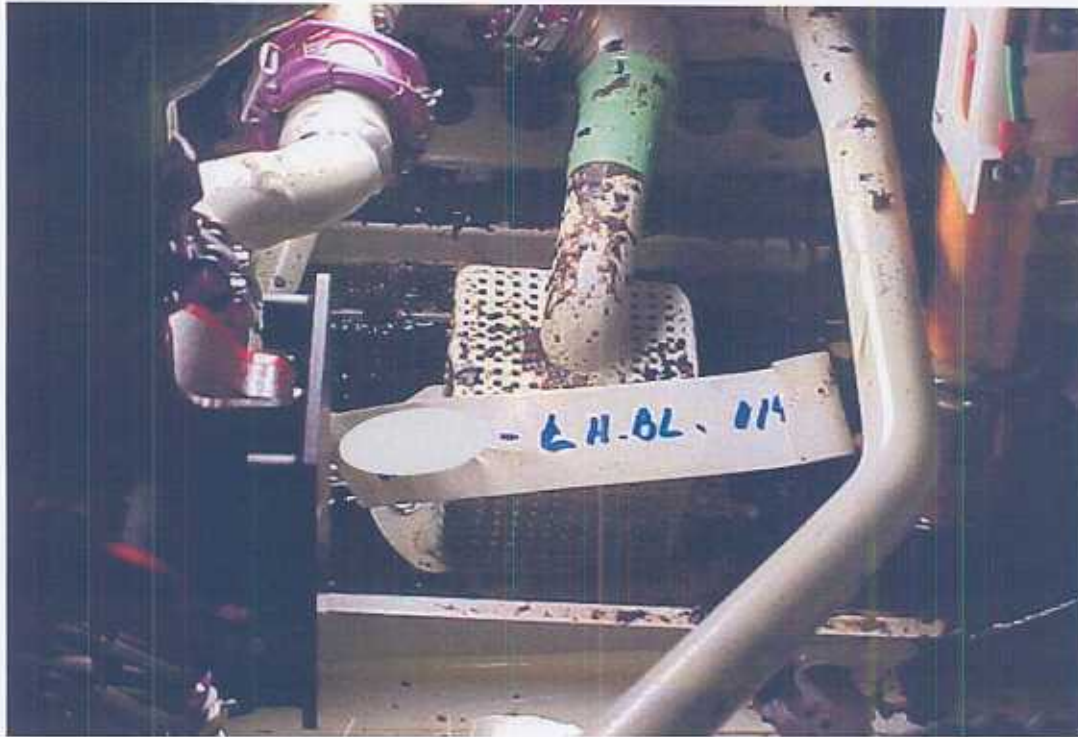
Evidence of microbiological growth.

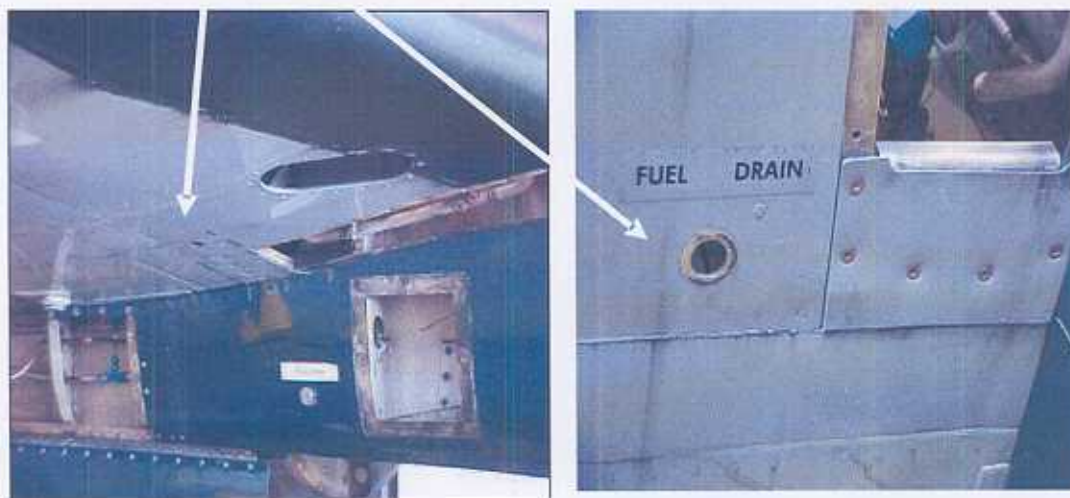
Note location of drain hole

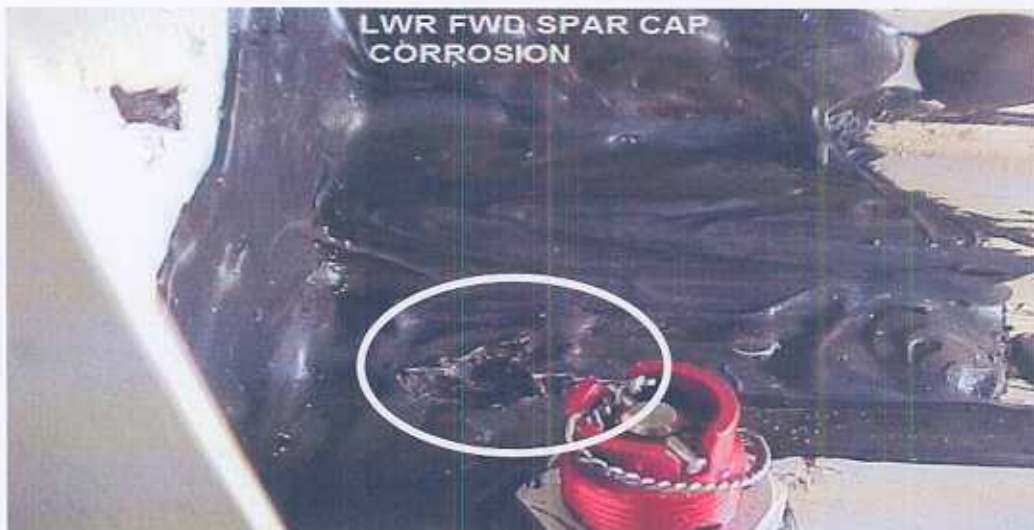
Evidence of microbiological attack

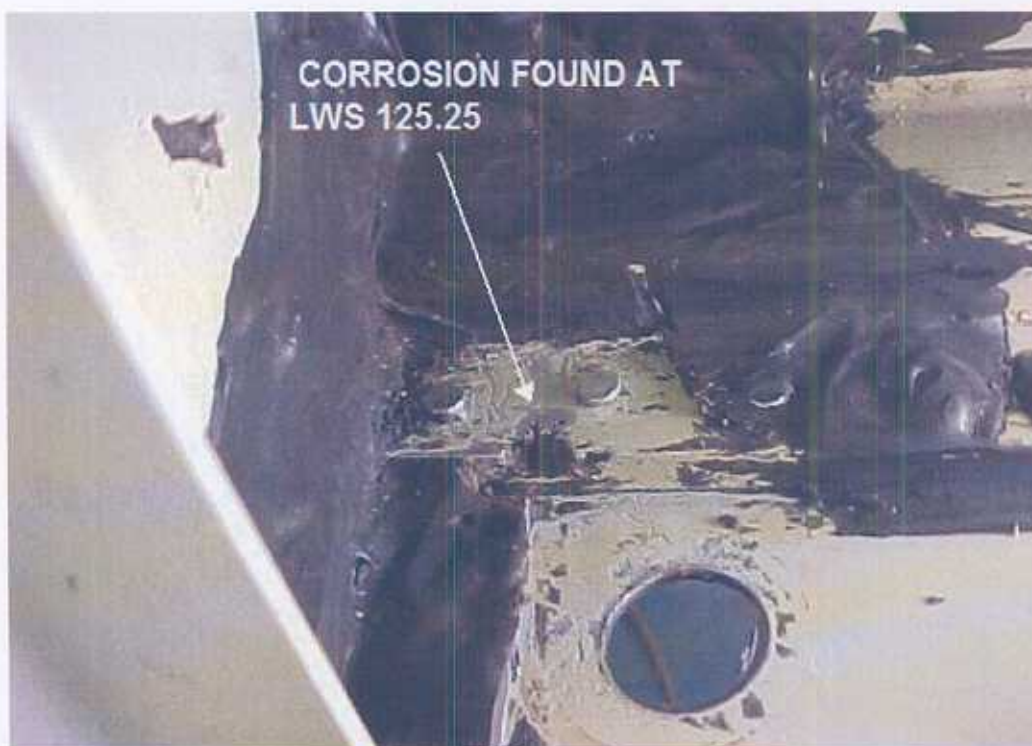
Note damage to spar flange

- 1) If evidence of microbiological contamination is found or sealant is deteriorated;
  - i. Clean the collector tank and area forward of the main spar.
  - ii. At the initial inspection, remove the tank sealer from the forward flange of the main spar from the inboard bulkhead outboard of WS 124 for approximately 4 inches.
  - iii. Inspect the forward flange of the main spar for evidence of microbiological attack. (see photos)
  - iv. If evidence of microbiological attack is discovered, contact Raytheon Aircraft Airline Technical Support at 316-676-2000 before taking further action.
- 2) If evidence of microbiological attack is not detected, reseal area Refer to the 1900 Structural Repair Manual 51-30-05 for preparation and resealing instructions.
