Communique

Airliner 1900 Series

Communiqué #71
June 25, 2004

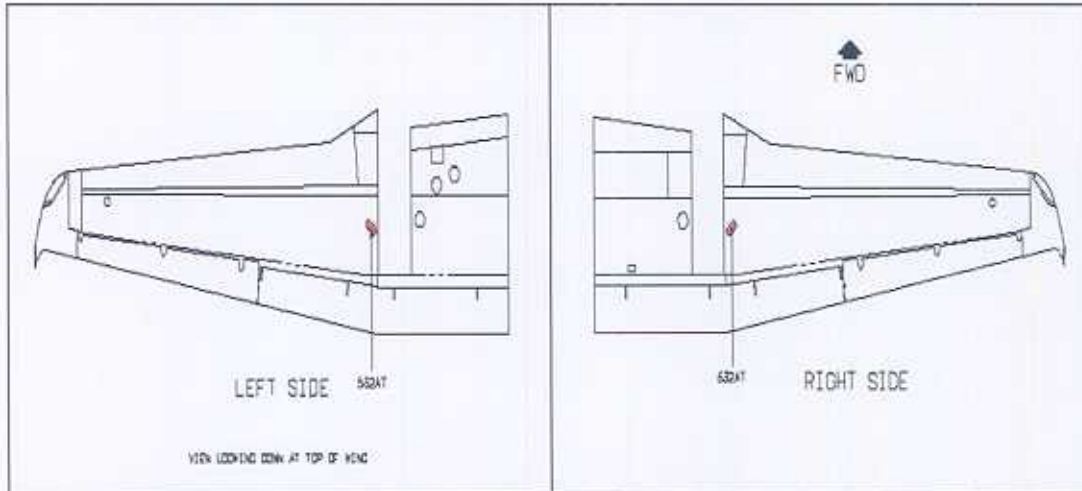
The collector tank area may be accessed from the top by removing panels 532AT and 623AT,

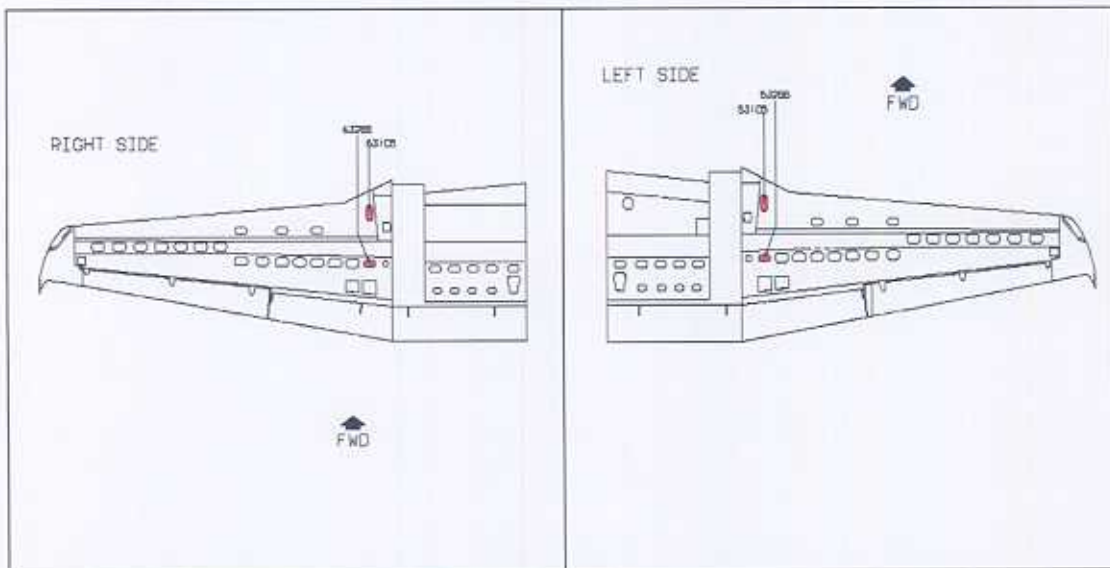
and from the bottom by removing panels 531CB/6321CB and 532BB/632BB.
